## The Case of the Missing CVTs

**Tom Parkinson**

2 September 2015

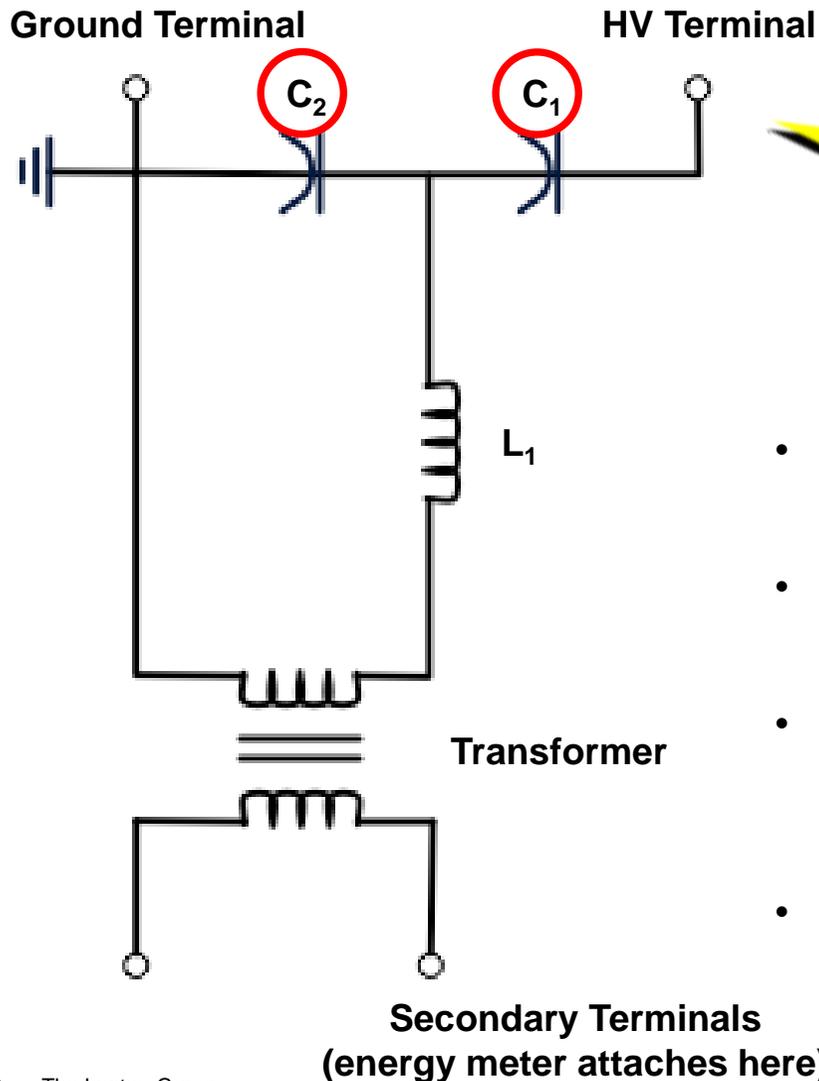
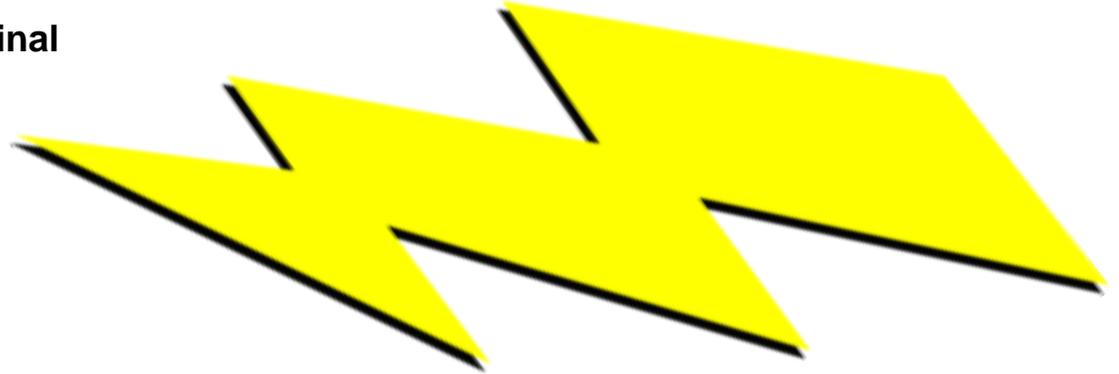
# The measurement errors related to failures of the capacitive voltage transformers (CVTs) – which led to six being swapped out

- Station operators recorded voltages at each of the 24 CVTs once a month
- Operators identified anomalous voltage levels for 6 of the 24 CVTs and called in the supplier
- Supplier concluded that there were voltage inaccuracies due to random failures in capacitor elements... and attributed failures to lightning strikes
- CVTs with anomalous voltage readings were replaced.

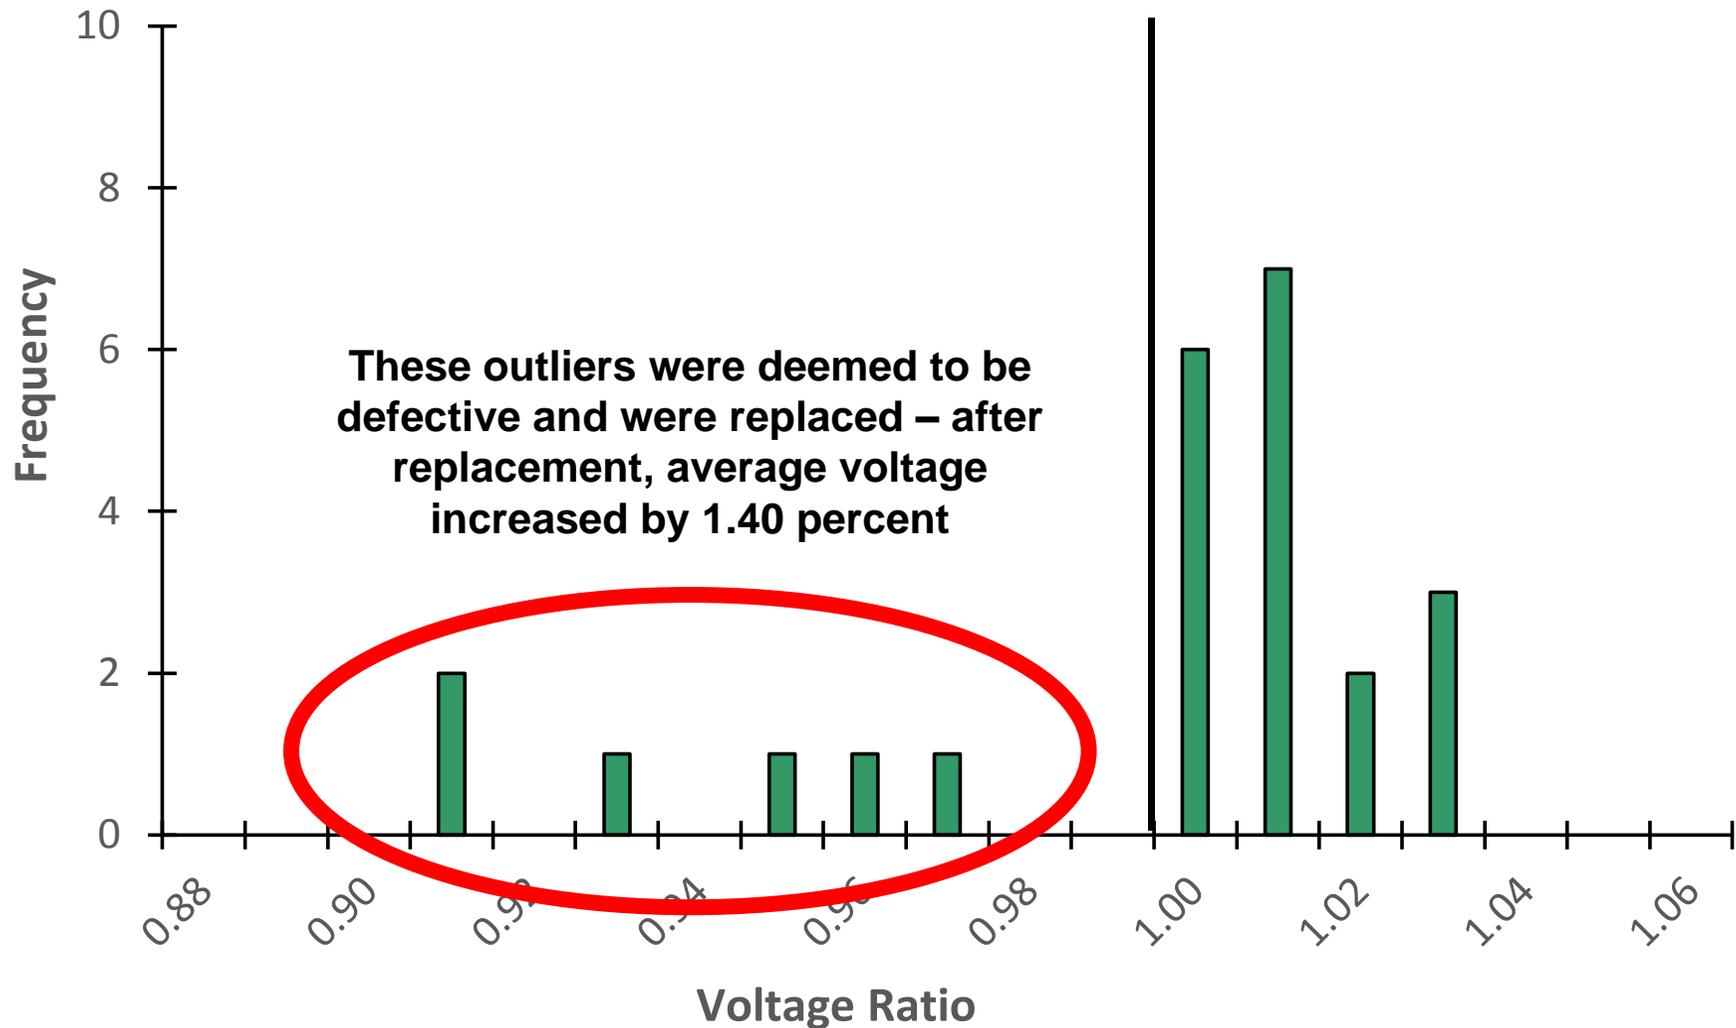
This figure displays average voltage measurements by CVT – relative to the average of all 24 CVTs – since there was no absolute standard (at the time)

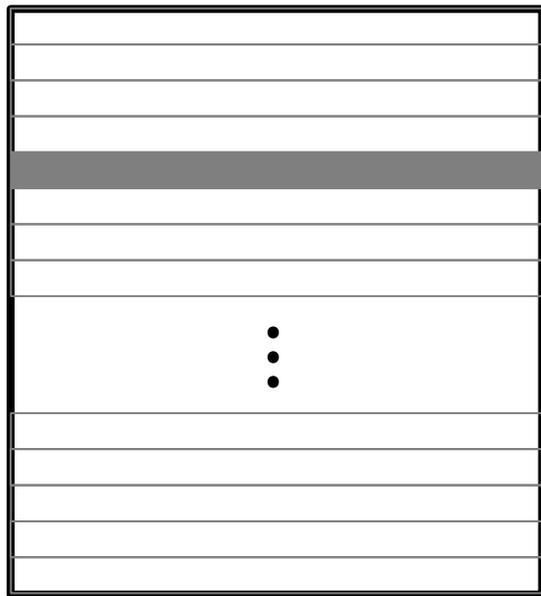
**C<sub>1</sub>**

**Capacitor C<sub>1</sub> –**

- Likelihood that an element in capacitor C<sub>1</sub> failed – given that a failure occurred – is thus  $191/(191+17) = 91.83$  percent
- Reduction in voltage given failure =  $1/(191+17-1) = 0.48$  percent
- Similarly, reduction in measured energy output = 0.48 percent

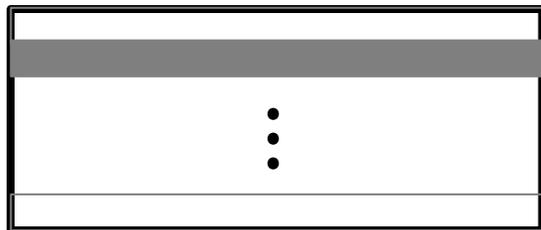
**C<sub>2</sub>**

**Capacitor C<sub>2</sub> –**

- Corresponding likelihood of C<sub>2</sub> failure =  $17/(191+17) = 8.17$  percent
- Reduction in voltage and measured energy output given failure =  $191/(17*(191+17-1)) = 5.43$  percent

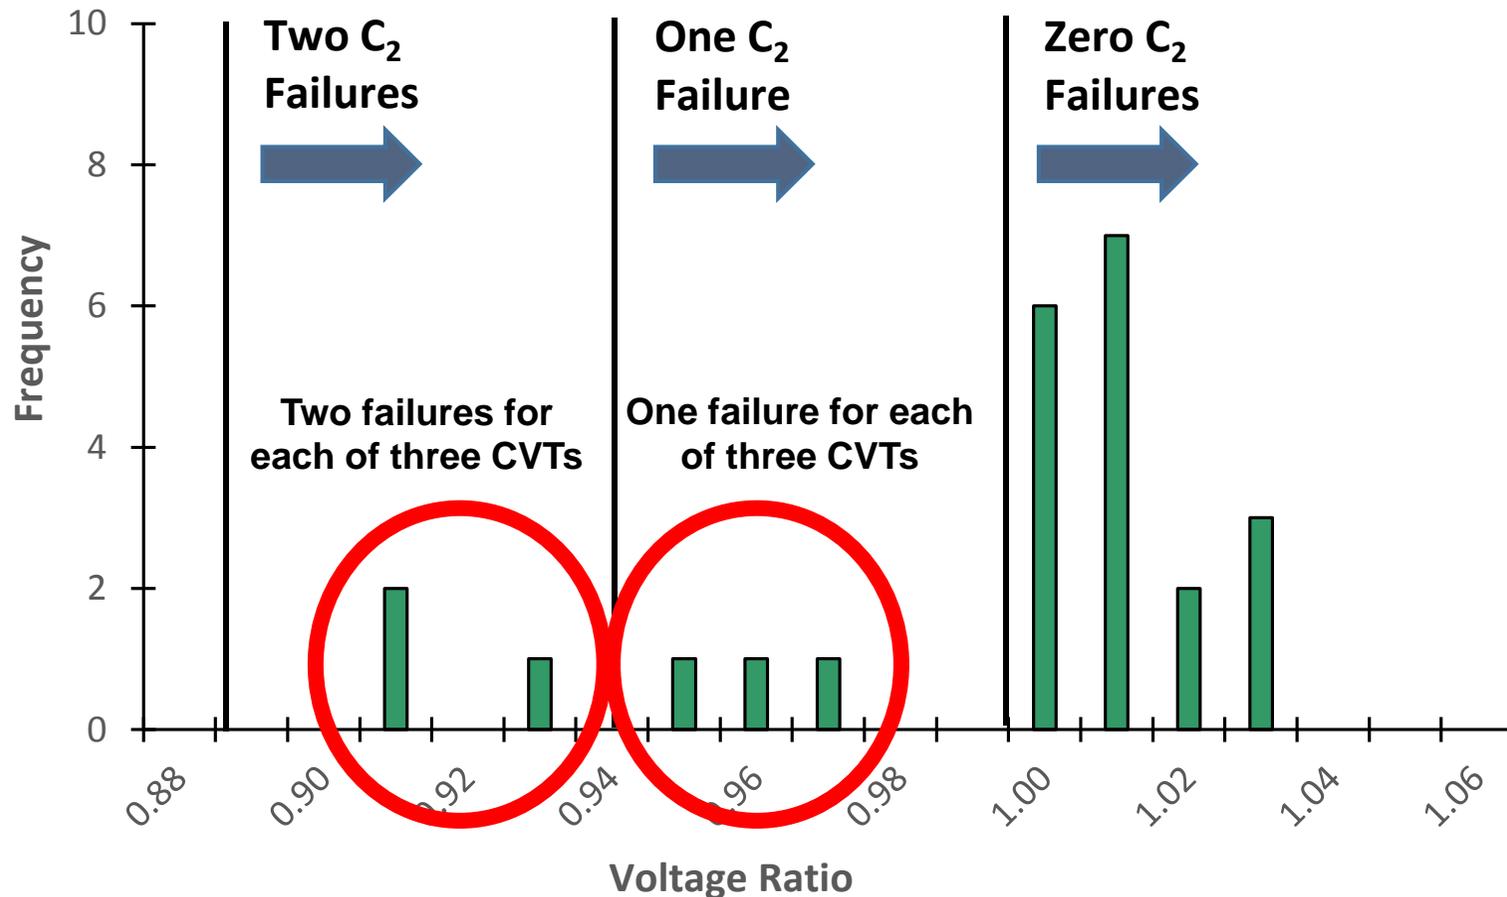
$C_2$  failures only reduce voltage, whereas  $C_1$  failures can only increase it (by a small amount) – this fact suggests that there are nine total  $C_2$  failures

9  $C_2$  failures across 24 CVTs suggests an average of 4.59 total failures per CVT

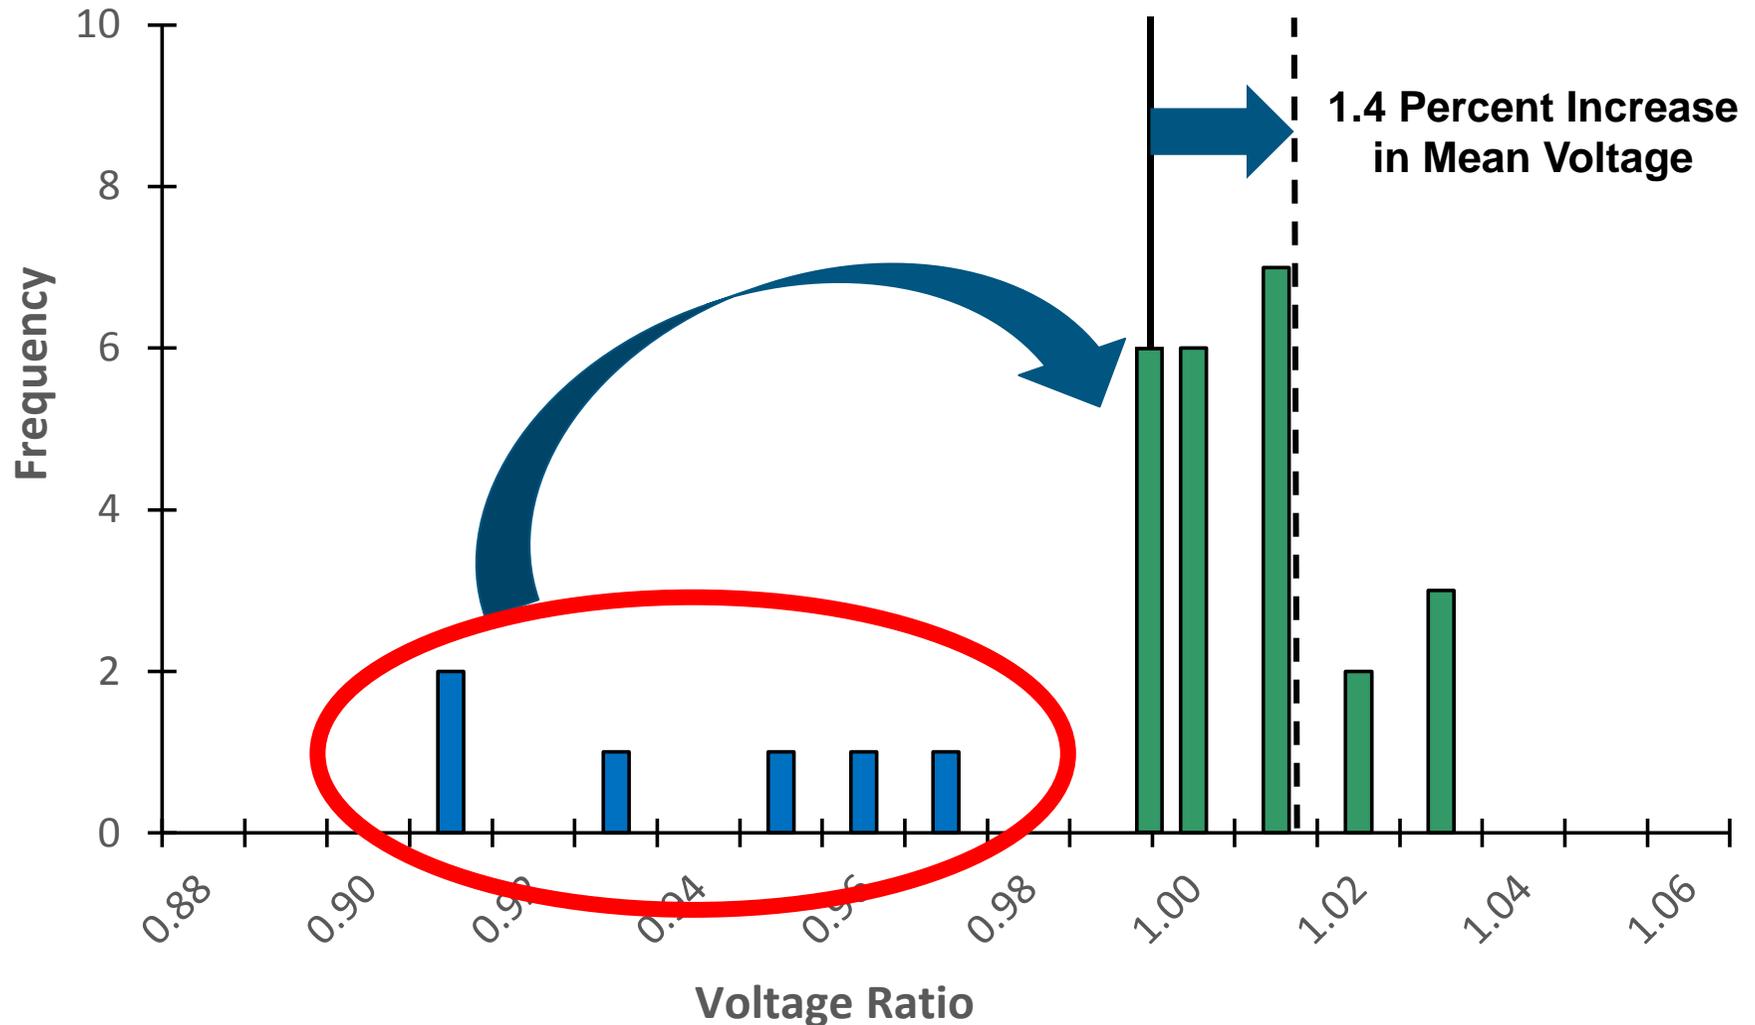
Thus, replacing those CVTs with C<sub>2</sub> failures skewed the voltage distribution of the “survivors” and thereby overstated energy generation by 1.4 percent.
