## The Case of the Missing CVTs

**Tom Parkinson**

2 September 2015

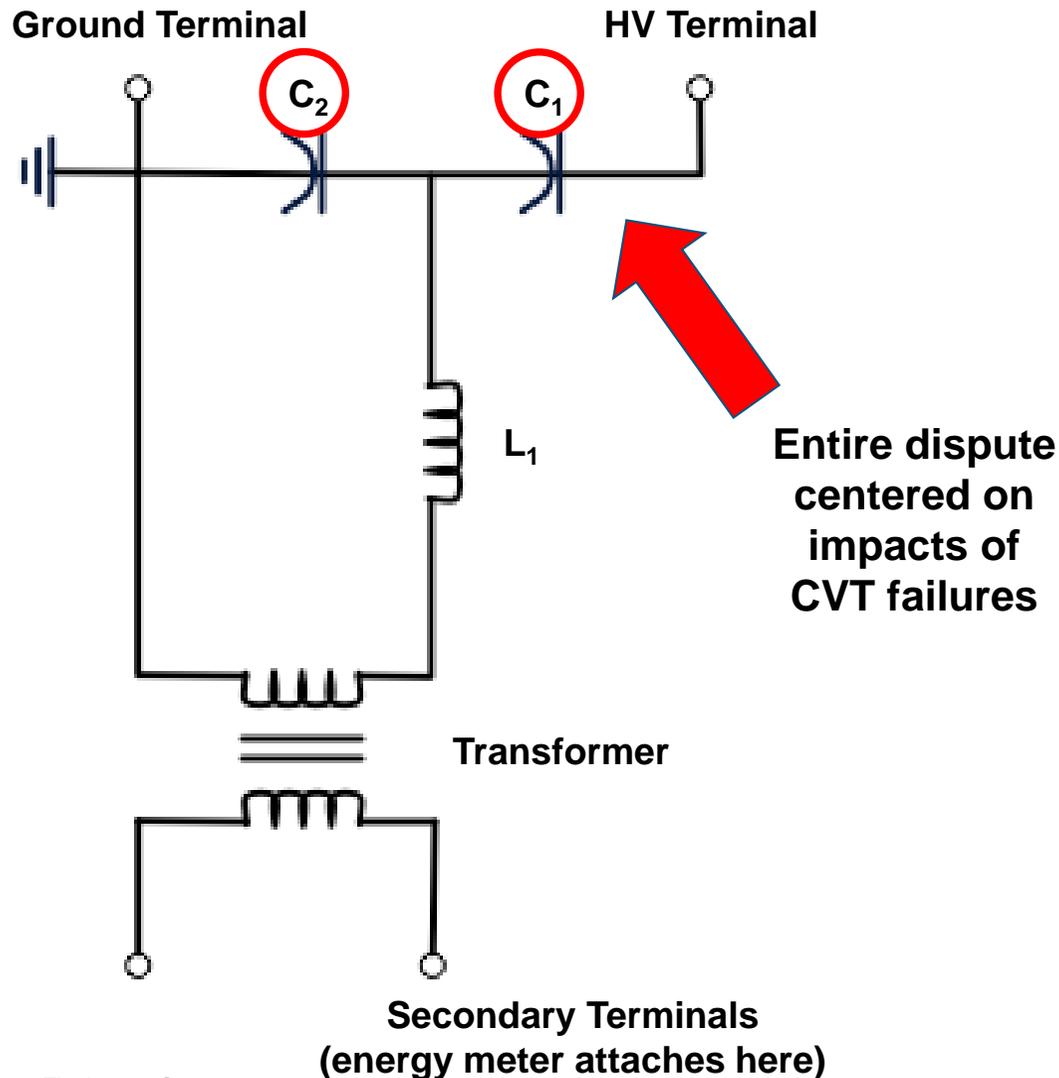
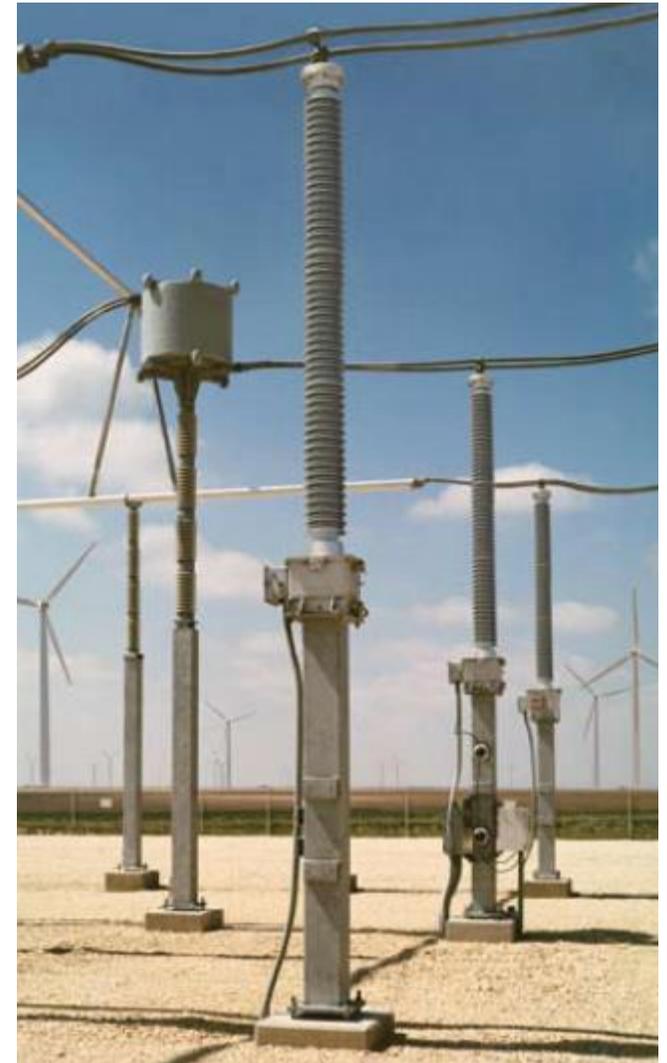
# The measurement errors related to failures of capacitive voltage transformers (CVTs)

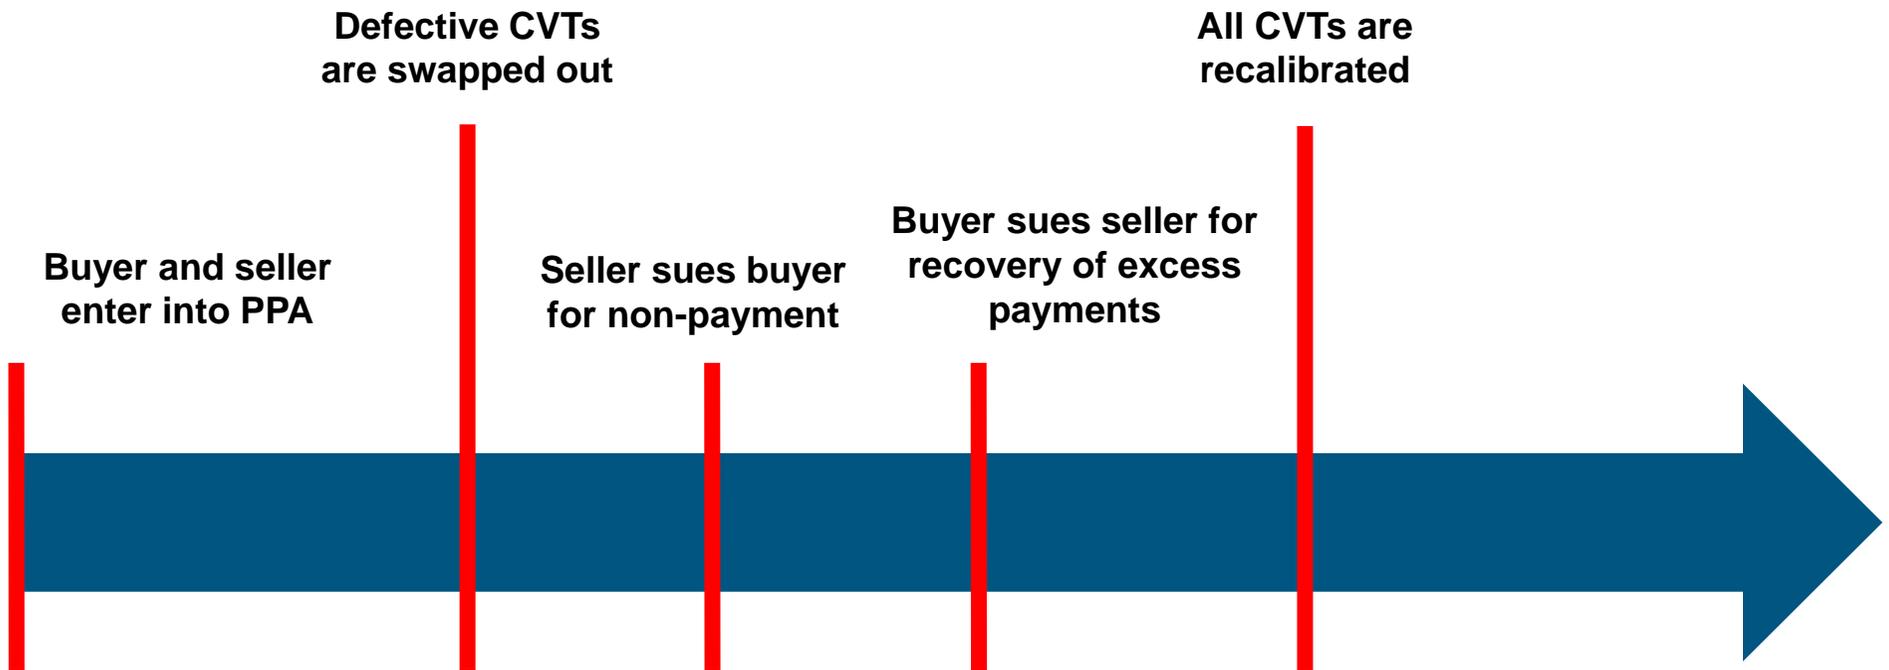
## The CVTs gave rise to several pertinent issues in the chronology

- Prior to any dispute, six CVTs were identified as defective and were swapped out for new units
- After the buyer filed the counter-claim, all CVTs were recalibrated.

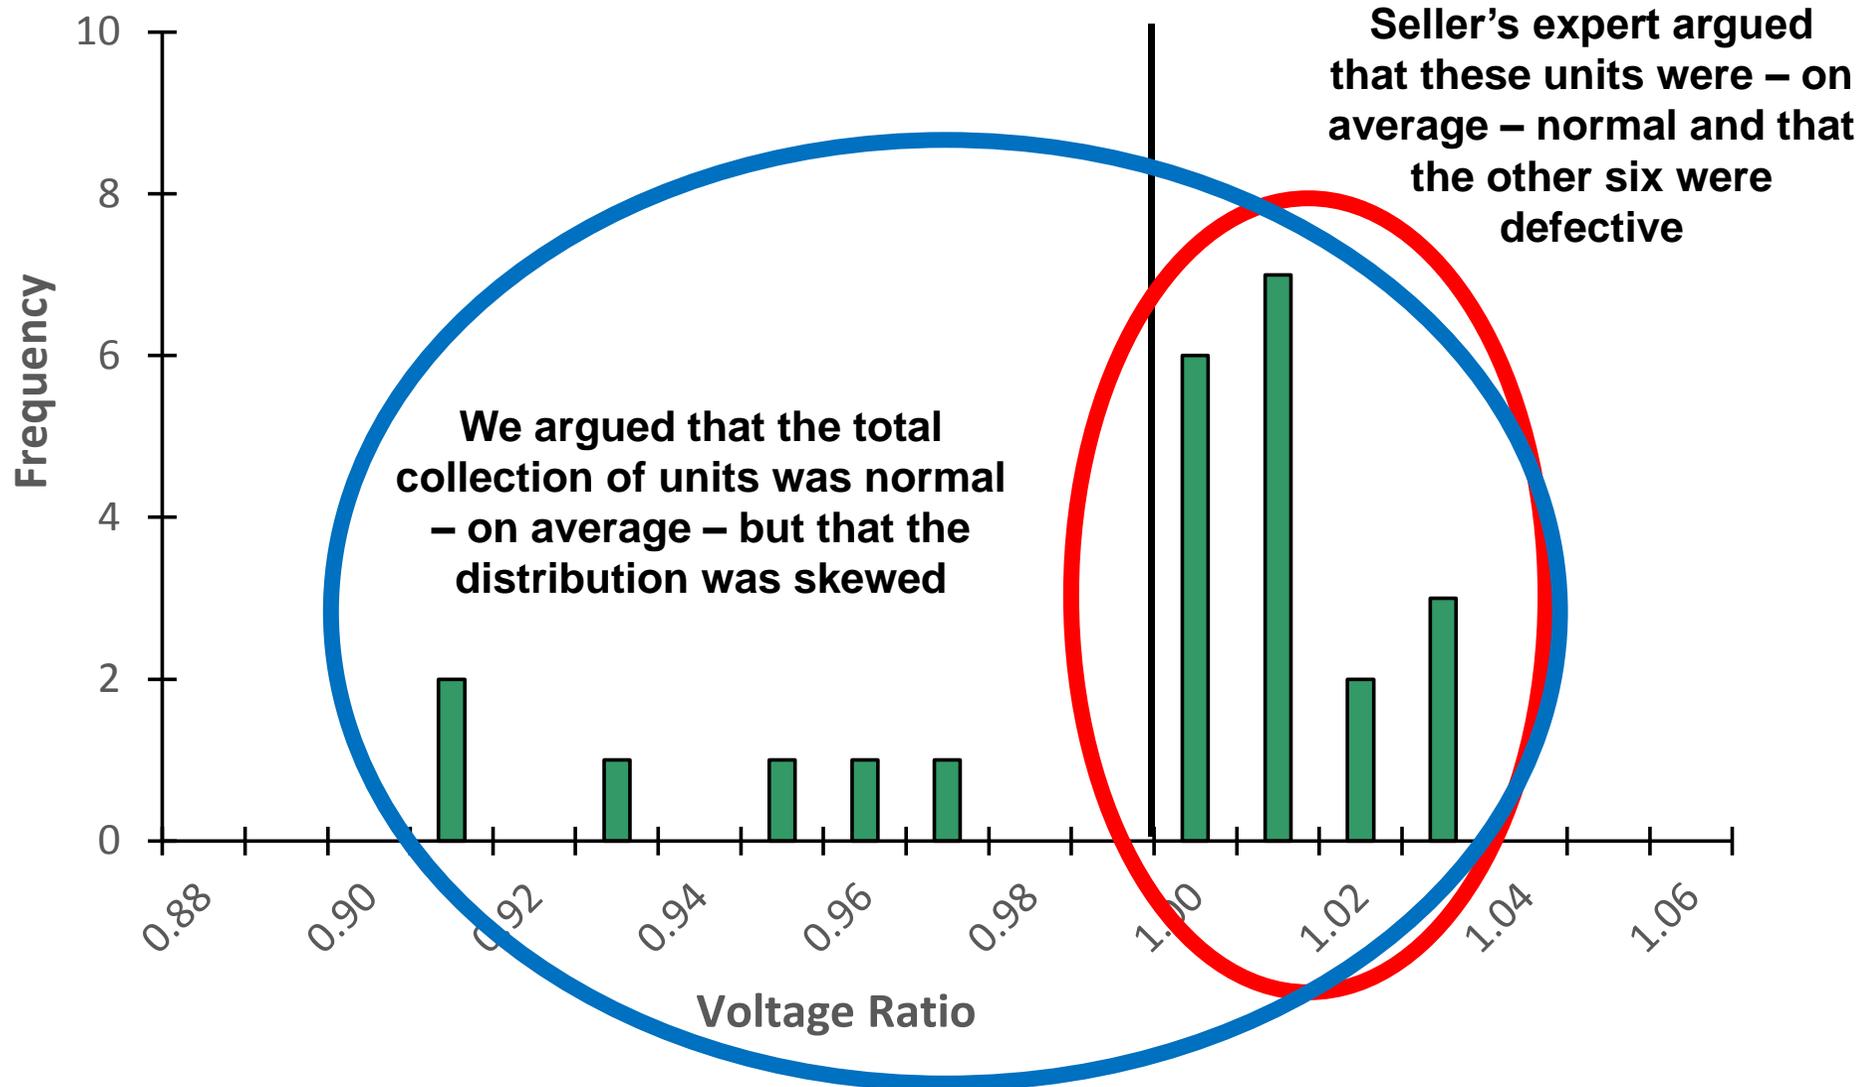
The damages case centered on the resolution of one central question – what defined “normal voltage”?

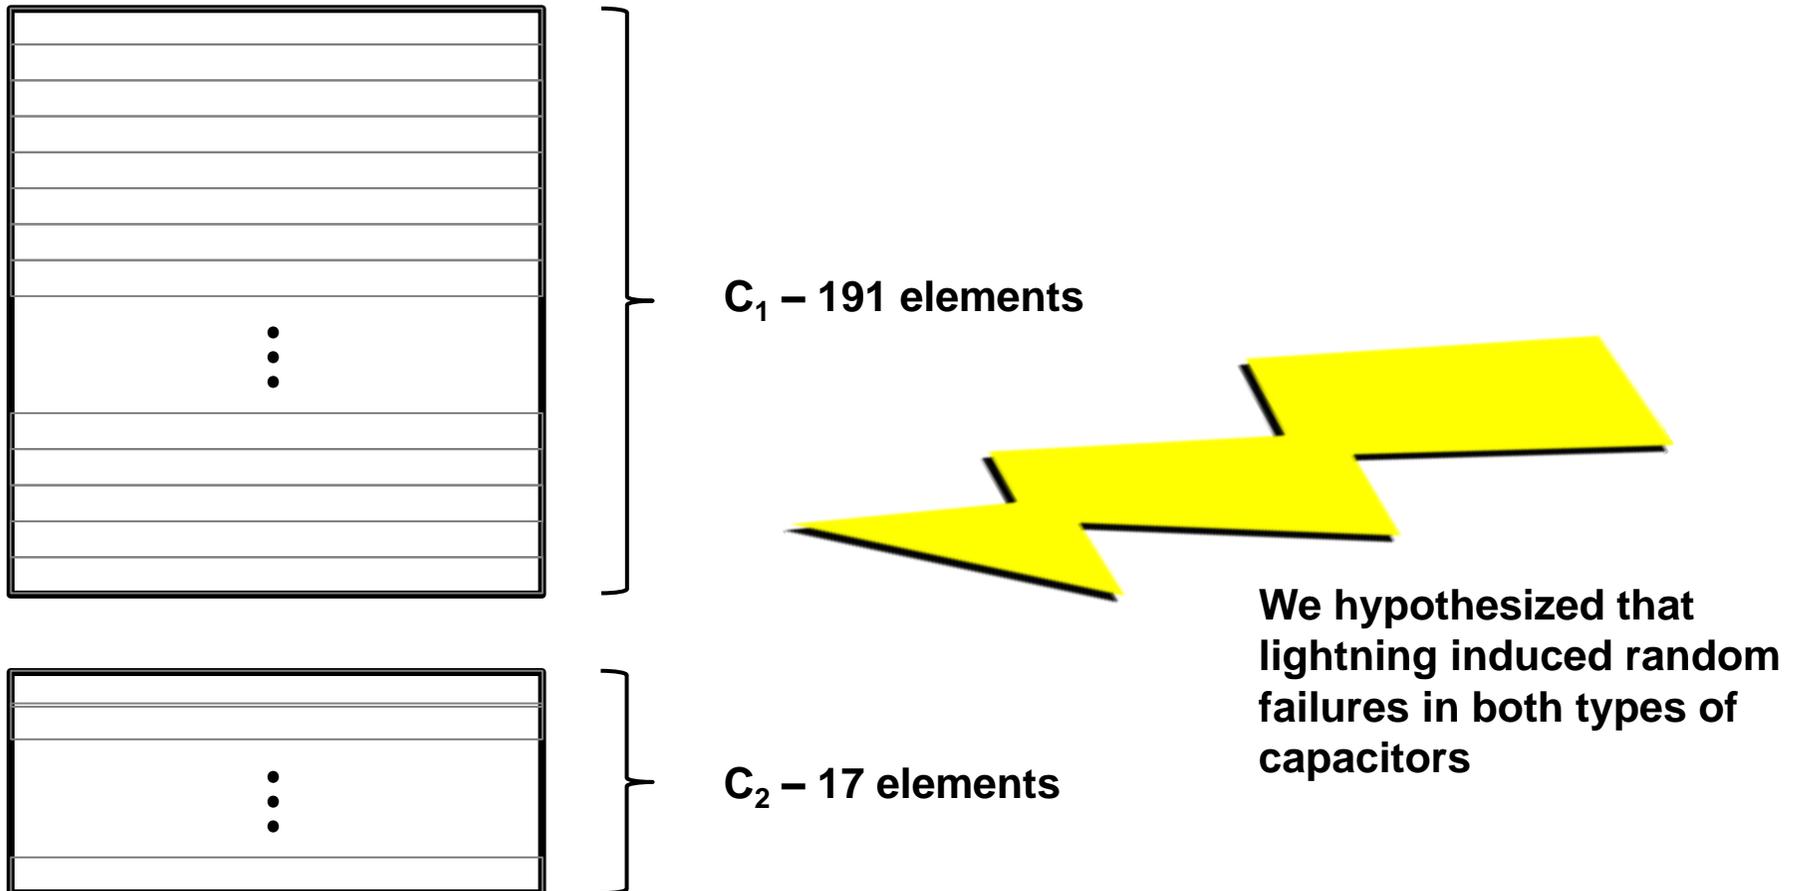
The two capacitors in each CVT –  $C_1$  and  $C_2$  – were composed of different numbers of identical capacitive elements

By that logic, the likelihood that an element of each capacitor failed is proportional to the number of elements in the capacitor

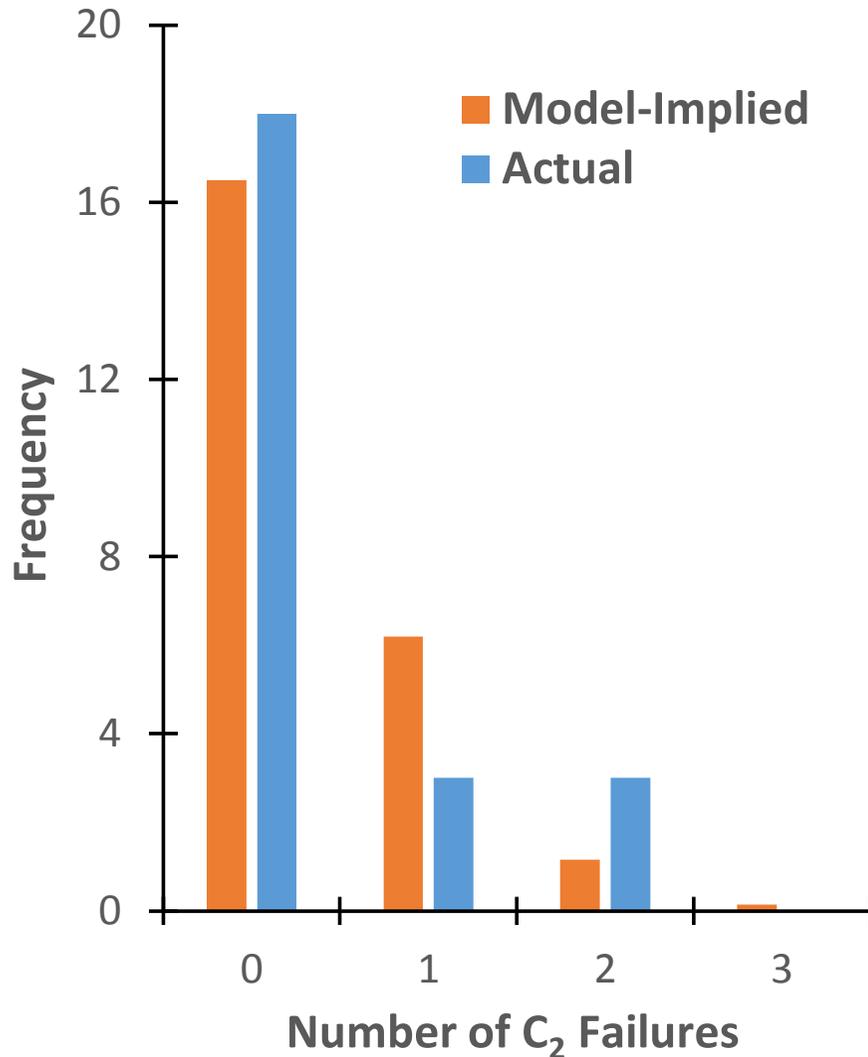
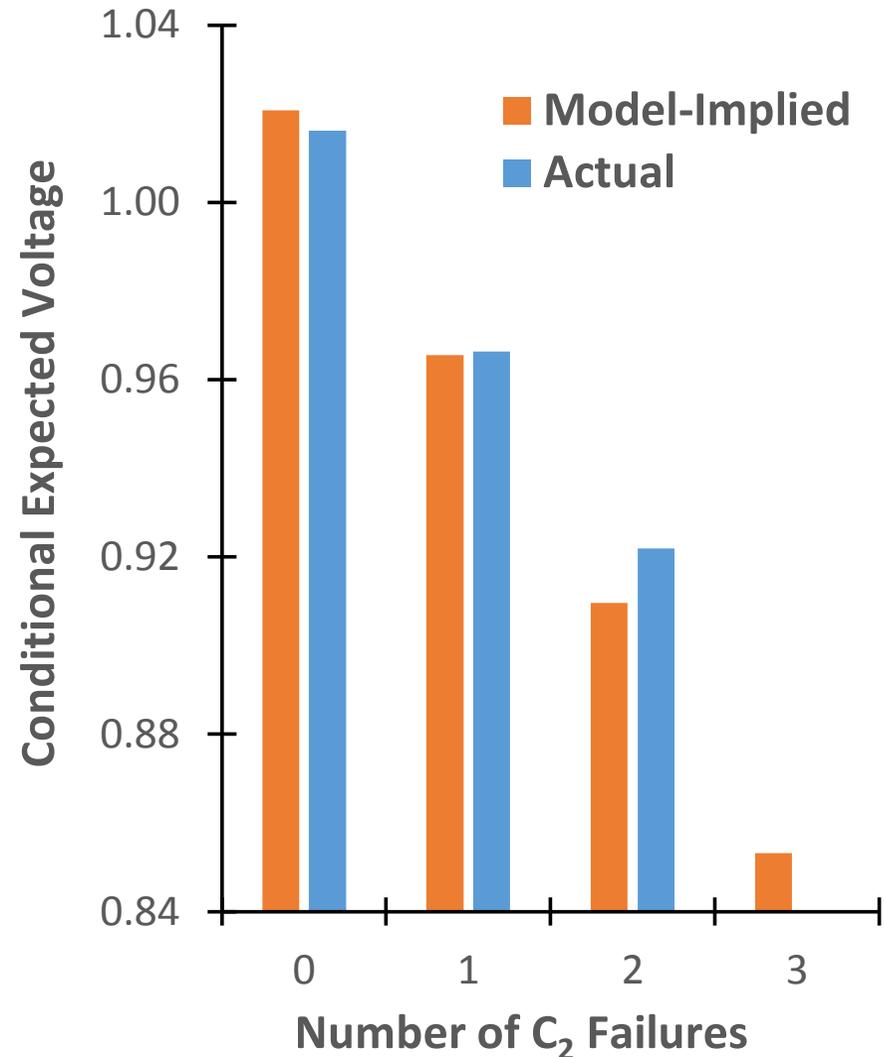
Given the total number of failures, we accurately projected the frequency of observed  $C_2$  failures and the expected voltage given number of  $C_2$  failures
